# Manhole Inspection Summary

Manhole # S37C\_\_012MH

Insp Date: **8/22/08 9:27 AM**

**Location** Address: **437 n front st**

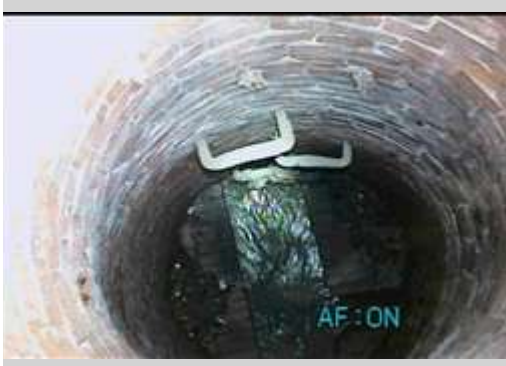
Defect 1

Count: **6** Missing: **2** ☒ **Corroded**

steps

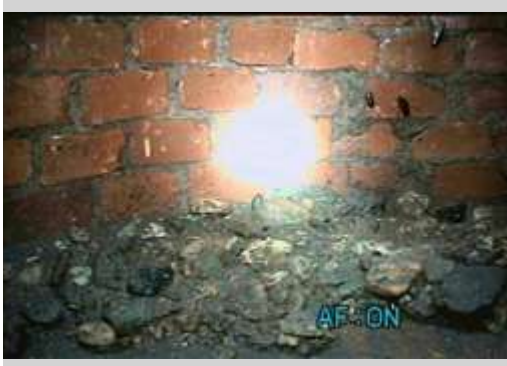
Defect 2

Condition: ☐ Sound ☐ Cracked ☐ Root Intrusion ☐ Deteriorated ☐ Leaks ☒ **Debris**

bench debris

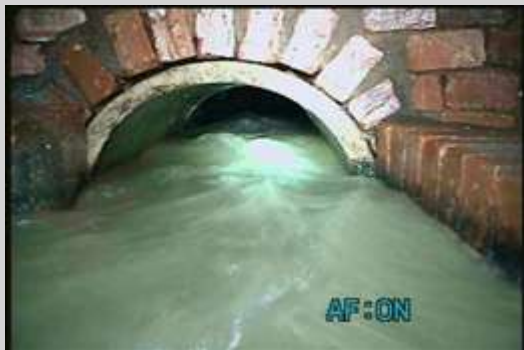
12 O'Clock Outflow

15 in. Circular Gravity Sewer  
Pipe Out @ 12 O'Clock

Invert Depth: **10.70** (ft.) Flow Characteristics: **Fast**

Deposits: ☒ None ☐ Mud ☐ Sludge ☐ Debris ☐ Grease

Infiltration: **None** Pipe Seal Cond: **Unknown**

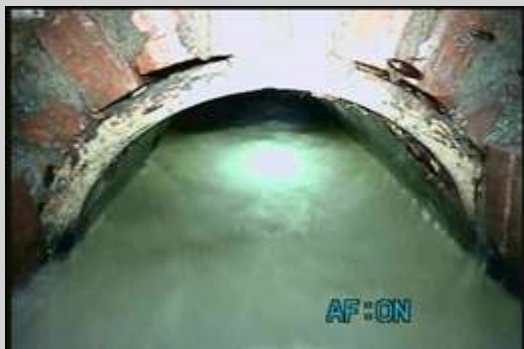
6 O'Clock Inflow

15 in. Circular Gravity Sewer  
Pipe In @ 6 O'Clock

Invert Depth: **10.60** (ft.) Flow Characteristics: **Fast**

Deposits: ☒ None ☐ Mud ☐ Sludge ☐ Debris ☐ Grease

Infiltration: **None** Pipe Seal Cond: **Unknown**

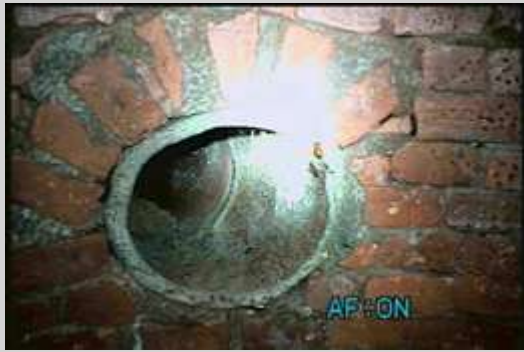
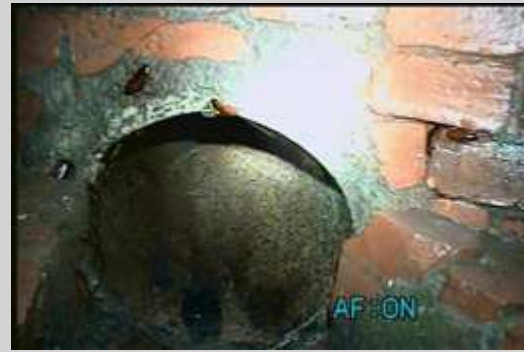
9 O'Clock Inflow

8 in. Circular Gravity Sewer

Pipe In @ 9 O'Clock

Drop In @ 9 O'Clock

Drop: **Outside Direct**

Drop Condition: **Open**
